Your Inspection Report

15940 Sample Street
Santa Cruz, CA

INSPECTION DATE:
Thursday, January 5, 2017

Report No. 1015, v.12

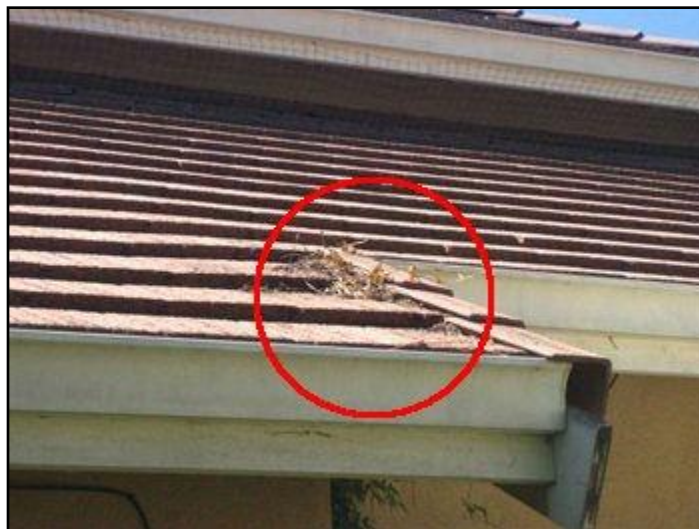
1. Condition: • Debris present on roof

Implication(s): Material deterioration

Location: Various

1. Debris present on roof

Task: Correct

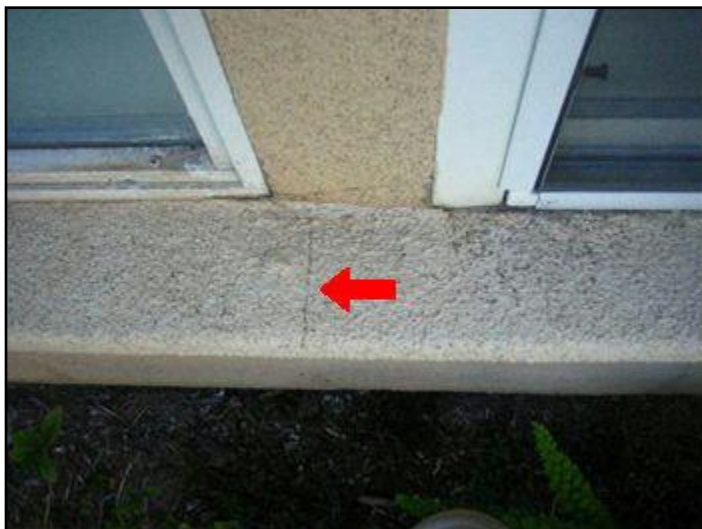
5. Condition: • Cracked

Implication(s): Material deterioration, Chance of water damage to contents, finishes and/or structure

Location: Various

2. Cracked

Task: Correct & Maintain

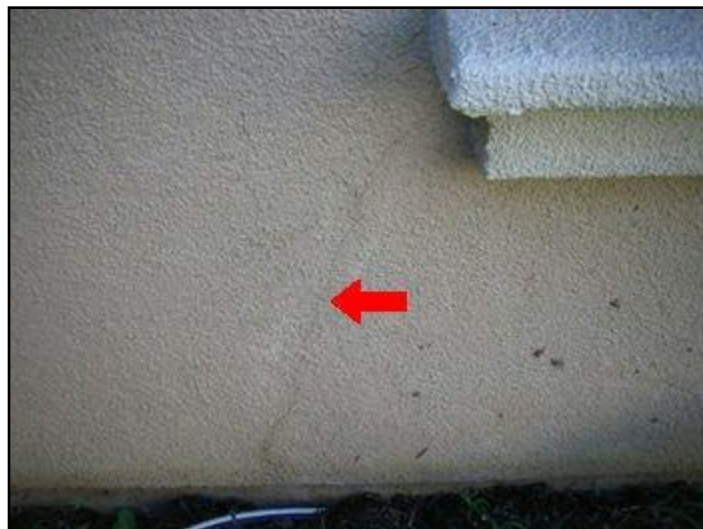
3. Cracked

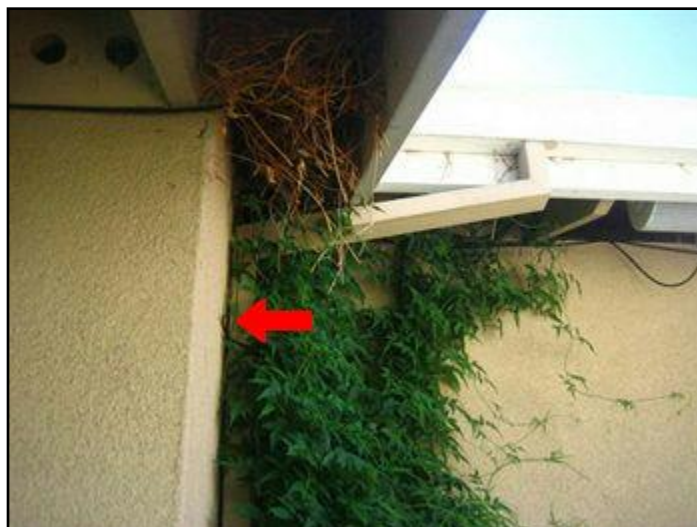
6. Condition: • [Trees or shrubs too close to building](#)

Implication(s): Chance of water damage to structure, finishes and contents | Chance of pests entering building | Material deterioration

Location: Rear

4. Trees or shrubs too close to building

Task: Correct & Maintain

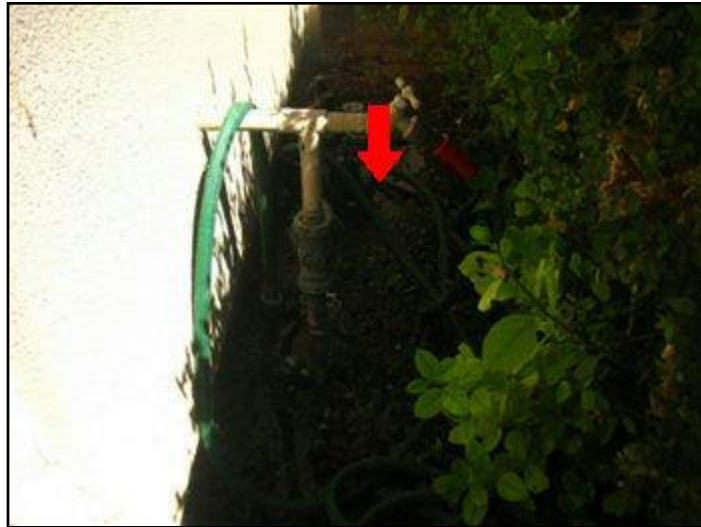
10. Condition: • Leak

Implication(s): Material deterioration, Chance of water damage to contents, finishes and/or structure

Location: Front Exterior

5. Leak

Task: Correct

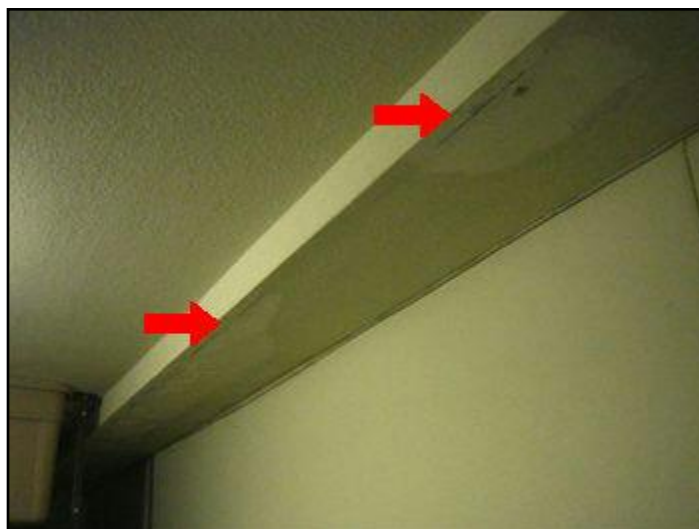
22. Condition: • Water stain(s). This condition may indicate active roof leakage. Further study advised

Implication(s): Material deterioration, Chance of water damage to contents, finishes and/or structure

Location: Garage

6. Water stain(s) noted

Task: Further evaluation

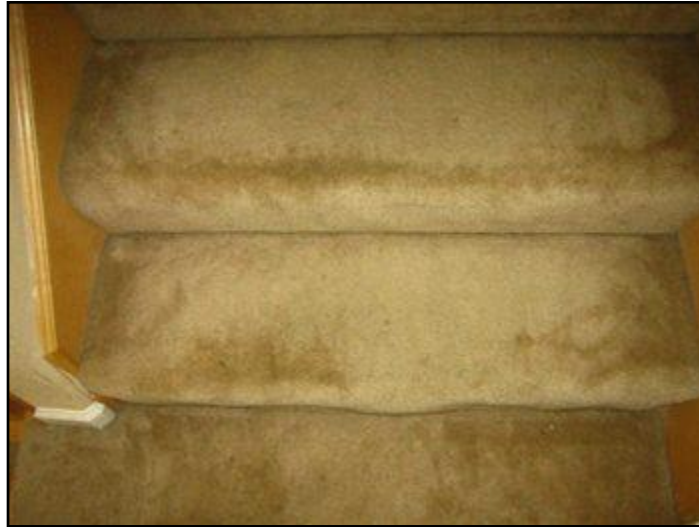
23. Condition: • Buckled

Implication(s): Trip hazard

Location: Various

7. Buckled

Task: Replace

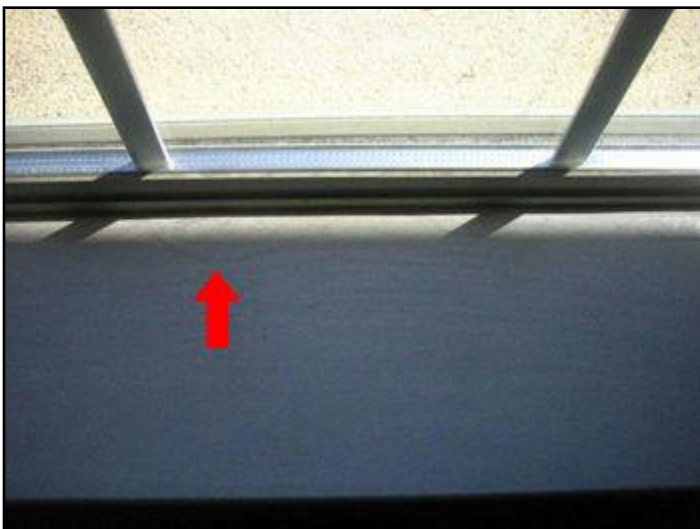
26. Condition: • Water stains. This condition may indicate active window leakage or excessive condensation. Further study advised

Implication(s): Material deterioration, Chance of water damage to contents, finishes and/or structure

Location: Bedroom

8. Water stains

Task: Correct & Monitor

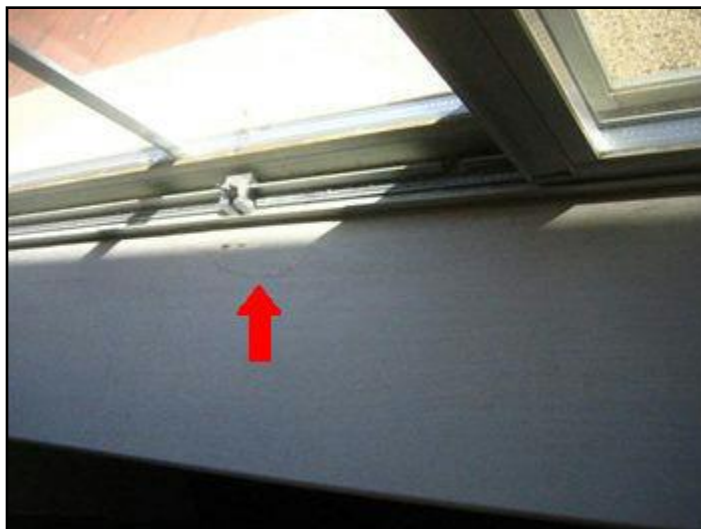
9. Water stains

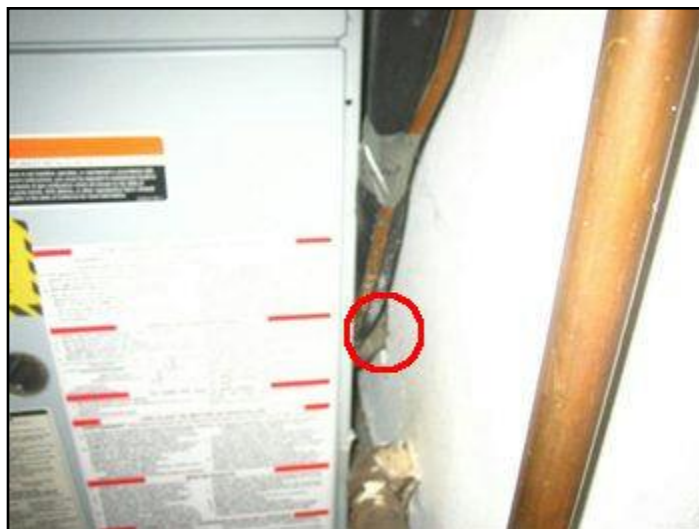
27. **Condition:** • Sealing needed at fire separation wall or ceiling

Implication(s): Increased fire risk, Chance of hazardous combustion products entering living space

Location: Garage

10. Sealing needed at fire separation wall

Task: Correct

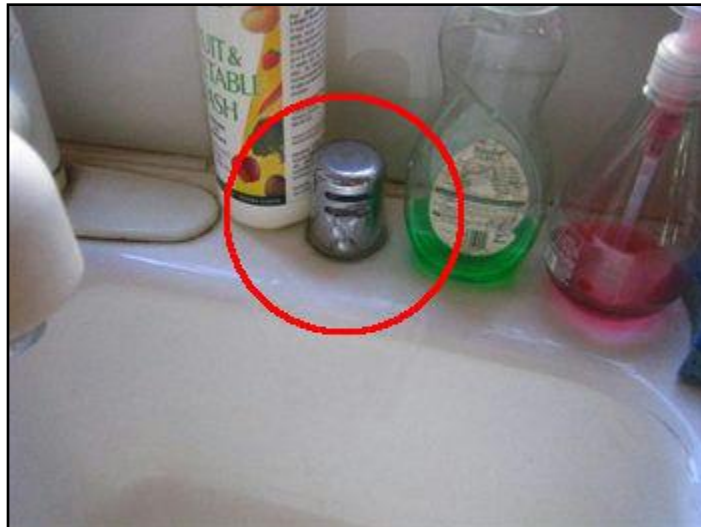
29. **Condition:** • Water drains from air gap

Implication(s): Equipment not operating properly, Chance of water damage to contents, finishes and/or structure

Location: Kitchen

11. Backflow prevention defective

Task: Correct
